Nose gear failure on landing roll, during instruction flight

Aircraft	Robin DR400-120 registered F-GABB
Date and time	Monday 4 April 2011 at 18 h 10 ⁽¹⁾
Operator	Club
Place	Le Touquet Paris-Plage aerodrome (62)
Consequences	Aeroplane severely damaged

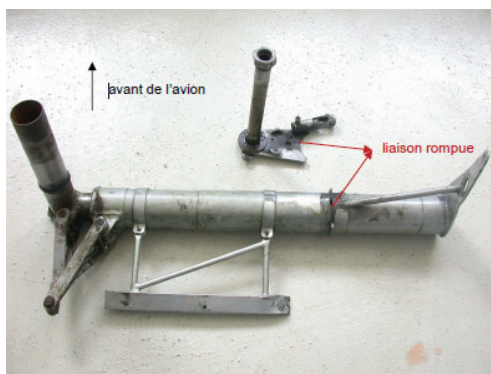
The nose gear, manufactured by Robin, failed at the weld seam linking the strut and the lower plate (see photos below). The examinations undertaken showed that:

General view of failed nose gear (left side)

- **EASA, in collaboration with the DGAC, implement a technical solution in order to prevent the appearance of new failures of this type and, consequently, modify Airworthiness Directive EU-2010-0231. [Recommendation FRAN-2012-031]**

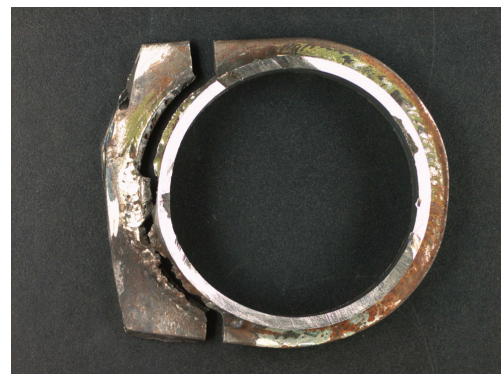
- There were several welding defects in the failed seam: penetration defects all around the circumference, porosity-type blowholes, local hole in the strut;
- The weld seam cracks propagated progressively from the existing defects, from the root to the weld surface;
- The final failure occurred when the remaining section succumbed to the loads exerted during the landing.

General view of failed weld seam (from below)

The accident was caused by defects in the welding on the landing gear, which the inspections made mandatory by Airworthiness Directive EU-2010-0231 did not make it possible to detect. These defects led to fatigue cracking in the weld seam between the lower plate and the strut, from the root towards the exterior, thus making it non-detectable through a surface inspection.

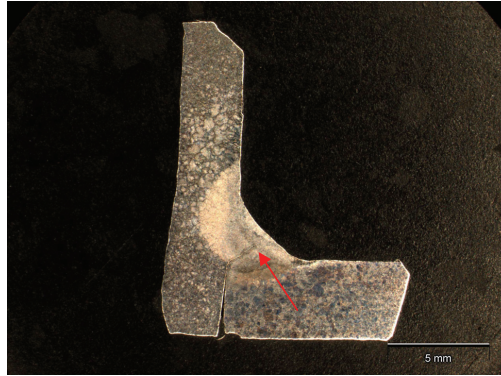
Example of crack propagation from the root of the weld seam (plate not broken on F-BOZM)

Since the fatigue cracks observed in the weld seams propagated from the root of the seam towards the exterior, a dye penetrant inspection of the surface did not allow such cracks to be detected.
